Figure 2-5
Mile 104 Tipton Arroyo

Integrated USIBWC Land Management Alternative

Targeted River Restoration Alternative

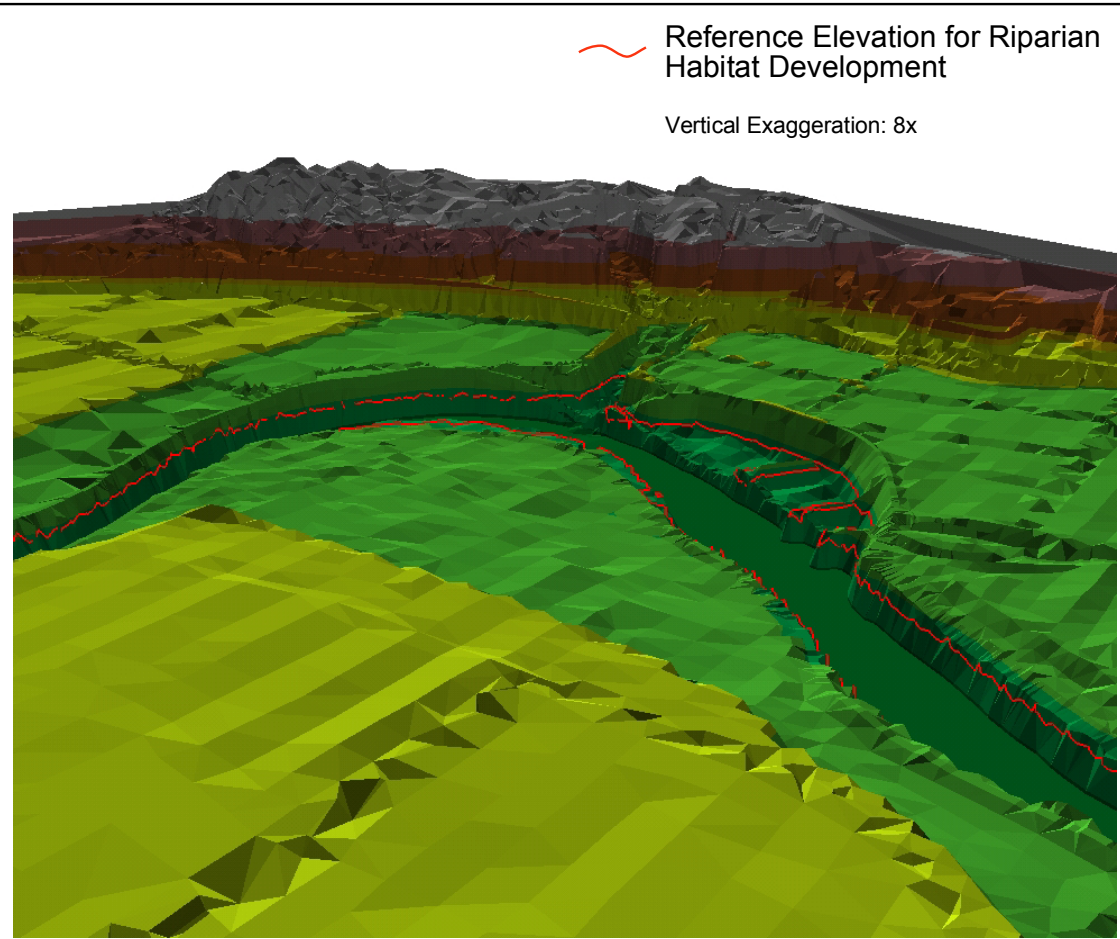
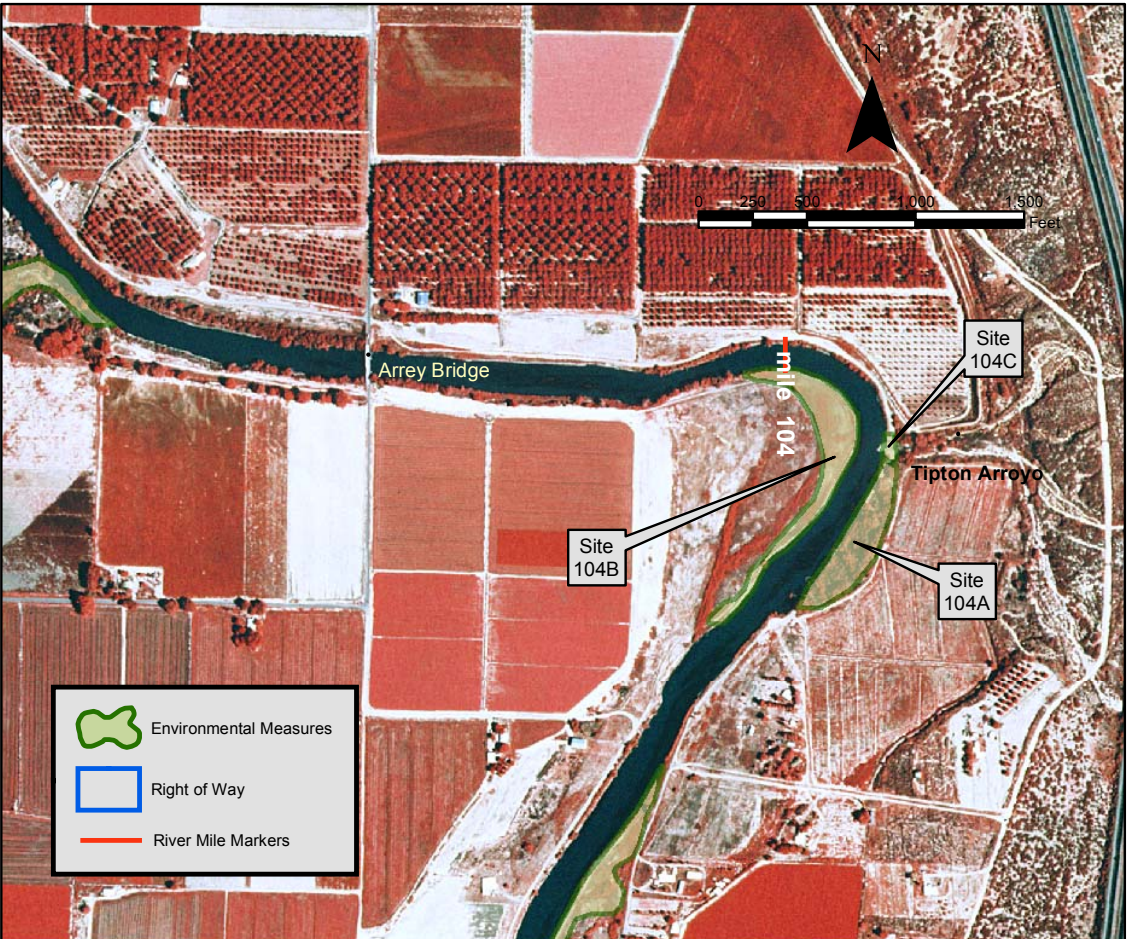
On the eastern shore, opposite a point bar, is the mouth of Tipton Arroyo. The mouth of the arroyo has been excavated to remove the “fan” of sediments entering the river. The watershed draining to Tipton Arroyo (identified as Misc.2 by USCOE) encompasses 2.2 square miles with numerous drainage channels leading from uplands to the east. The channels flow under U.S. Interstate 25 and combine into Tipton Arroyo near the Rio Grande.

<i>Point Project Measures</i>	ID	#	Area (ac)
Native Vegetation Planting/enhancement	104A	1	2.52
Bank shave downs*	104B	1	3.4

<i>Point Project Measures</i>	ID	#	Area (ac)
Planting/enhancement	104A	1	2.52
Modify dredging at arroyos by creating embayments	104C	1	0.2
